REPORT DOCUMENTATION PAGE		READ INSTRUCTIONS BEFORE COMPLETING FORM
1. REPORT NUMBER	2. GOVT ACCESSION NO.	3. RECIPIENT'S CATALOG NUMBER
	AD-A091279	
4. TITLE (and Subtitle) Phase I Inspection Report Lake Welch Dam Hudson River Basin, Rockland County, NY Inventory No. 283		5. TYPE OF REPORT & PERIOD COVERED Phase I Inspection Report National Dam Safety Program

Examination of the available documents and visual inspection of the Lake Welch Dam did not reveal conditions which constitute a hazard to human life or property.

PHASE I INSPECTION REPORT
NATIONAL DAM SAFETY PROGRAM
LAKE WELCH DAM
I.D. NO. N.Y. 283
DEC #196-854
HUDSON RIVER BASIN
ROCKLAND COUNTY, NEW YORK

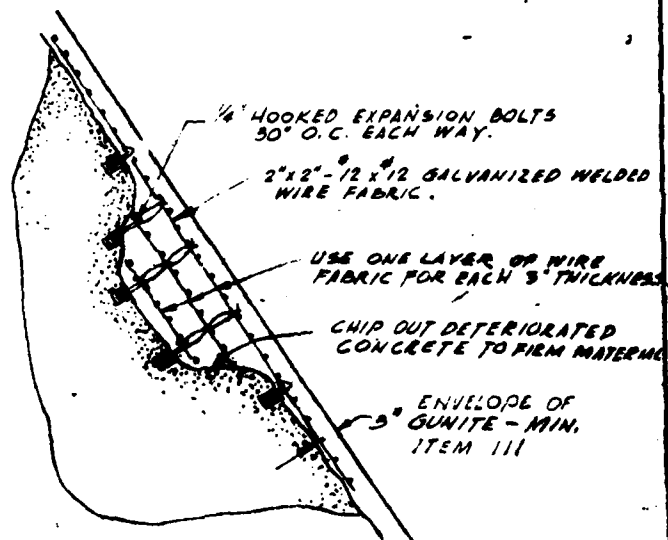
TYPICAL DAM REPAIR
NOT TO SCALE

REPAIR - LAKE WELCH DAM
HARRIMAN STATE PARK ROCKLAND CO.
NEW YORK

DESIGNED BY	TITLE	DRAWING No.
DRAWN BY	DETAILS OF DAM REPAIRS	2
TRACED BY		
CHECKED BY		
DATE		
7/17/54		15 SHEETS
PALISADES INTERSTATE PARK COMMISSION DEAR MOUNTAIN NEW YORK
